**INSPECTION REPORT OF 60-YEAR OLD
4-INCH CAST IRON PIPE ENCASED IN LOOSE POLYETHYLENE
LAFOURCHE PARISH WATER DISTRICT NO. 1
LAFOURCHE PARISH, LOUISIANA
AUGUST 7, 2018**

INSPECTION REPORT OF 4-INCH CAST IRON PIPE ENCASED IN LOOSE POLYETHYLENE LAFOURCHE PARISH, LOUISIANA

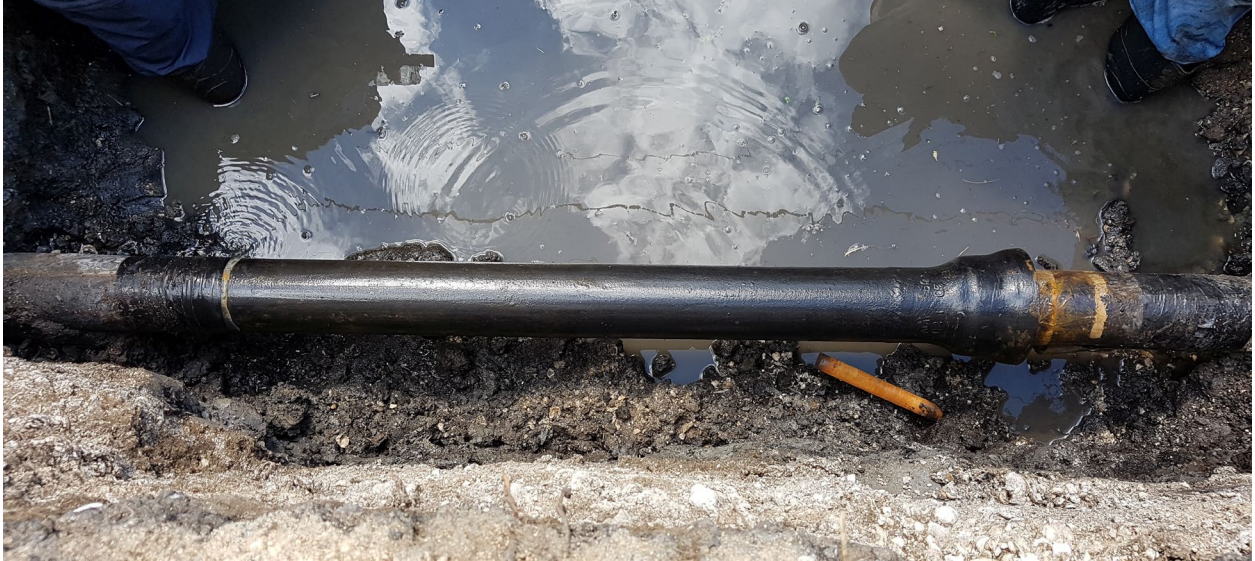
C: Encasement removed; after cleaning and sounding of the pipe surface. The oxidation was found to be completely superficial, with no pitting observed at any point along the exposed length of pipe.

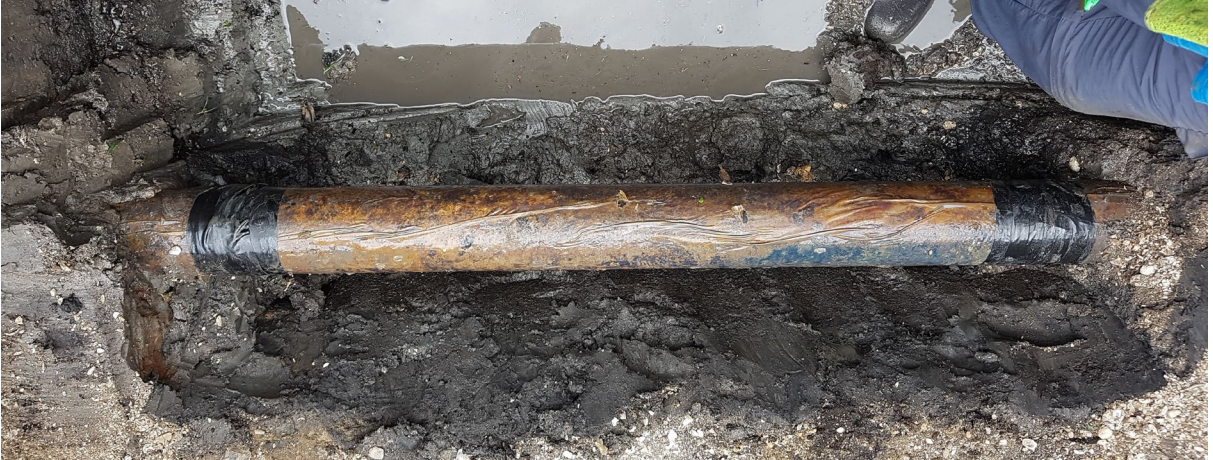
D: Site 2 - Prior to removal of polyethylene film

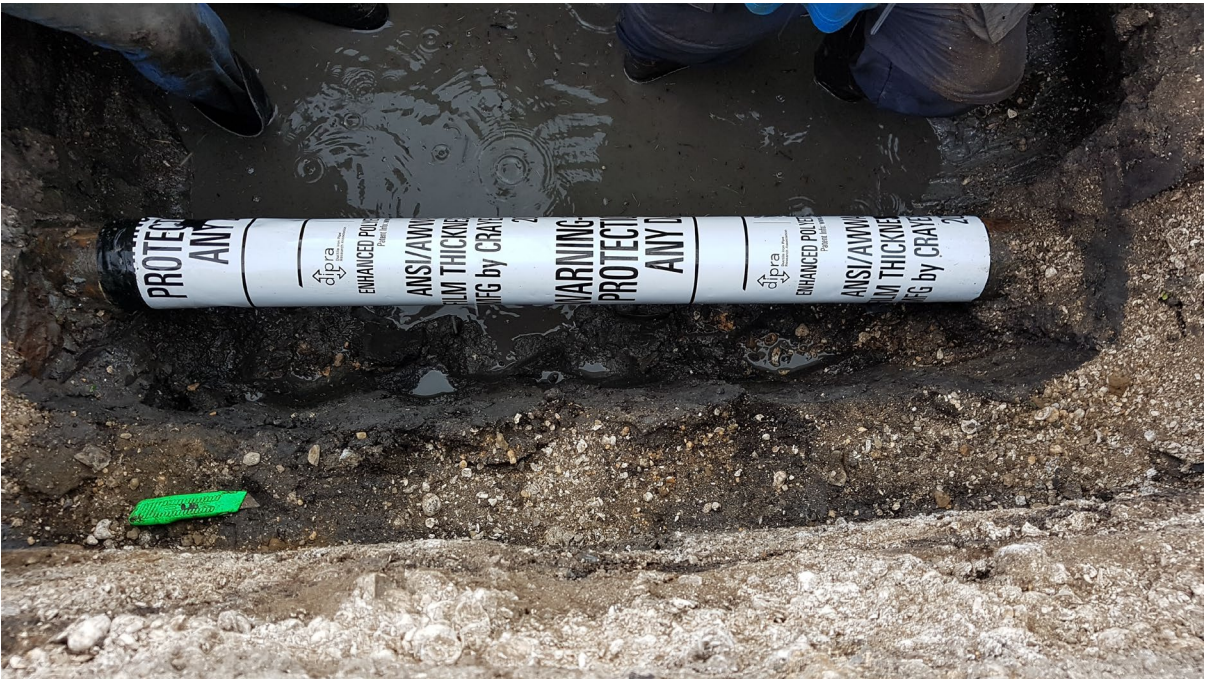
G: Pipe encased in V-Bio[®] enhanced polyethylene encasement prior to backfilling
