Ductile Iron Pipe
Research Association

TAPPING

Direct Service Connection Installation Comparison Ductile Iron Pipe vs. Polyethylene Pipe

by Richard W. Bonds, P.E.

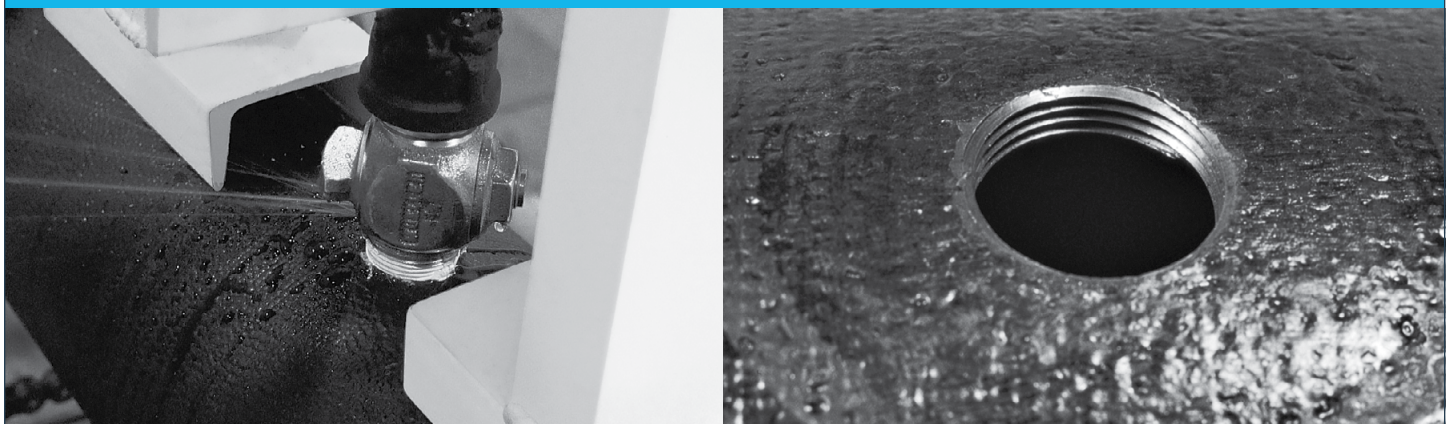
FIGURE 2

Pull-Out Test — Ductile Iron Pipe

Forces exerted during pull-out tests, when sufficient, resulted in failure of the corporation stop, not the Ductile Iron Pipe or threads. The photo on the left shows leakage at the plug key of the corporation stop. Ultimate failure occurred to the corporation stops’ threaded connection for the service line. The undamaged Ductile Iron Pipe and threads are shown on the right.
